August 22, 2012

August 22, 2012 Storm

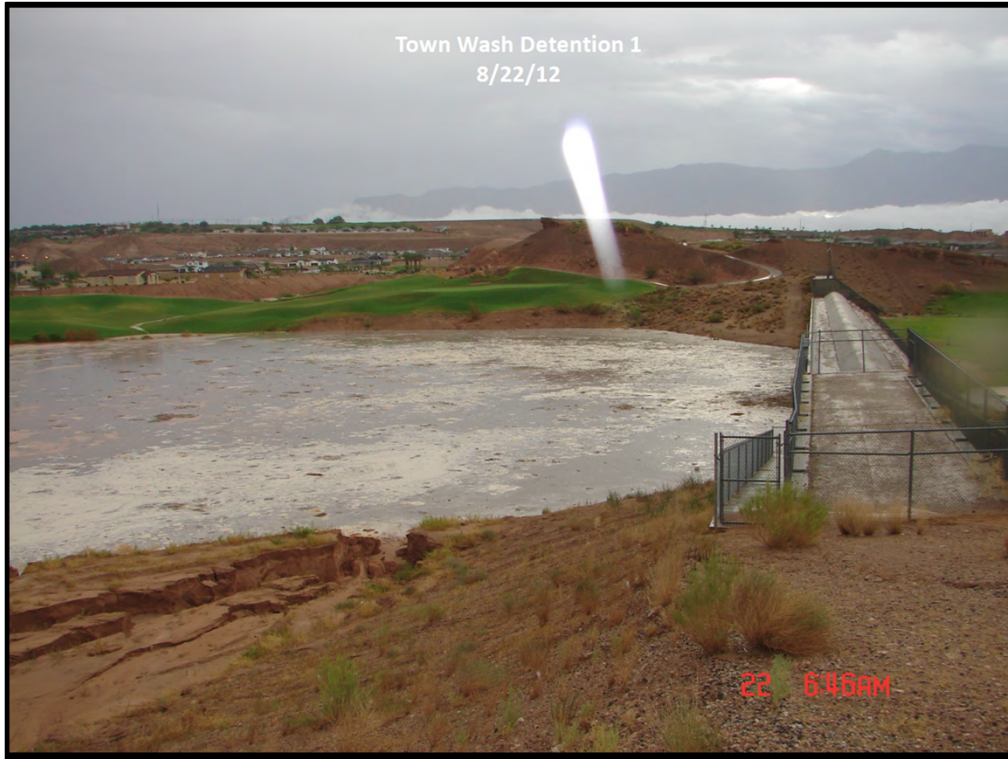
Here are a few photos of the aftermath of this storm. Jim Wilson (aka Town Wash) DB impounded 8.5 feet of runoff.

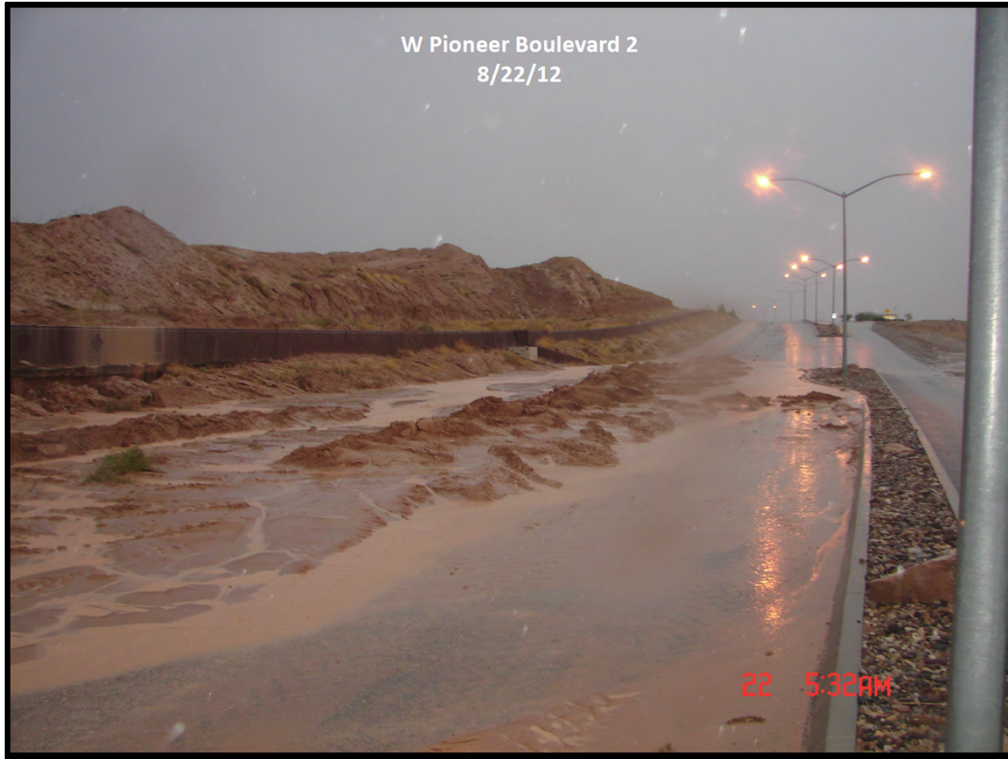
Damages in Mesquite were mostly limited to erosion of landscaped areas...

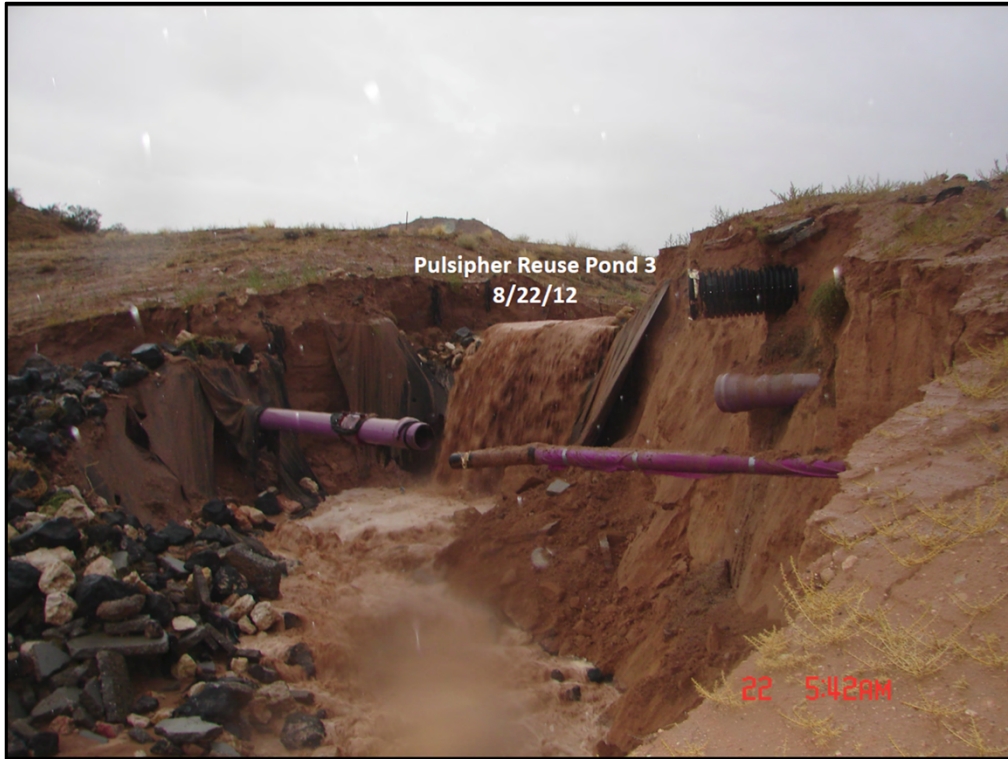
And clean-up of soils in the roadways.

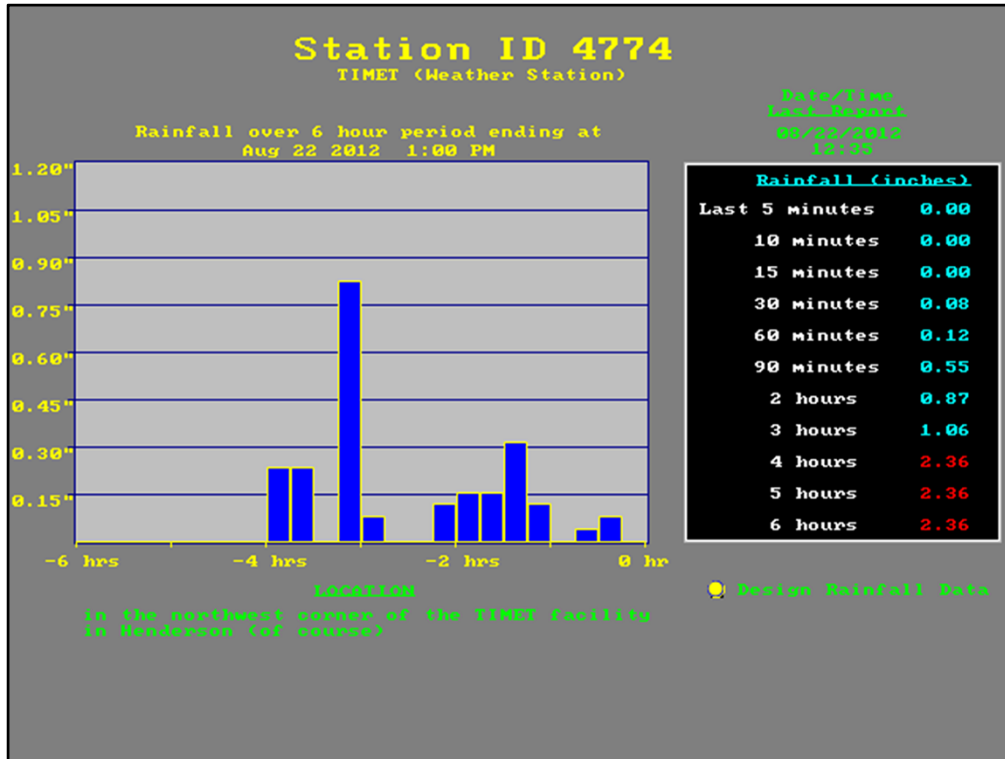
Here are a couple of slides to demonstrate the rainfall intensities during this event. Each vertical bar represents the rainfall during a 15-minute period. This was not particularly intense rainfall, but more than 2" rain fell in less than 4 hours.

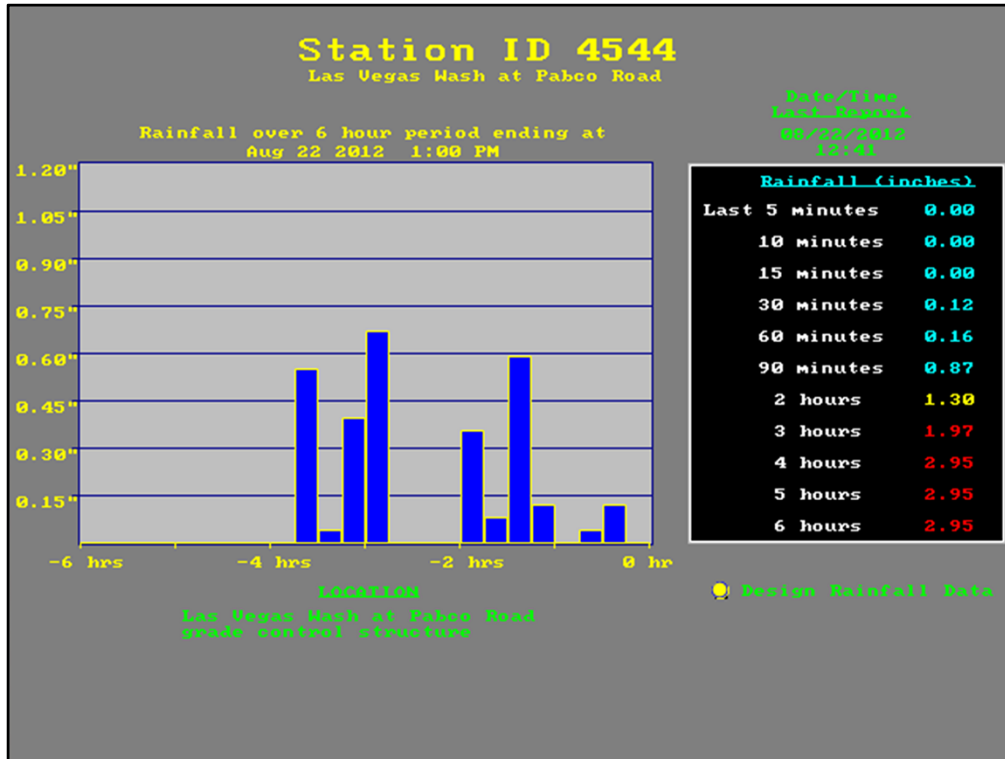
Again, more than 2" rain in less than 4 hours. The peak rainfall collected in 15 minute is 0.83" – intense, but only 10-25 year return interval by the District's adopted standard.

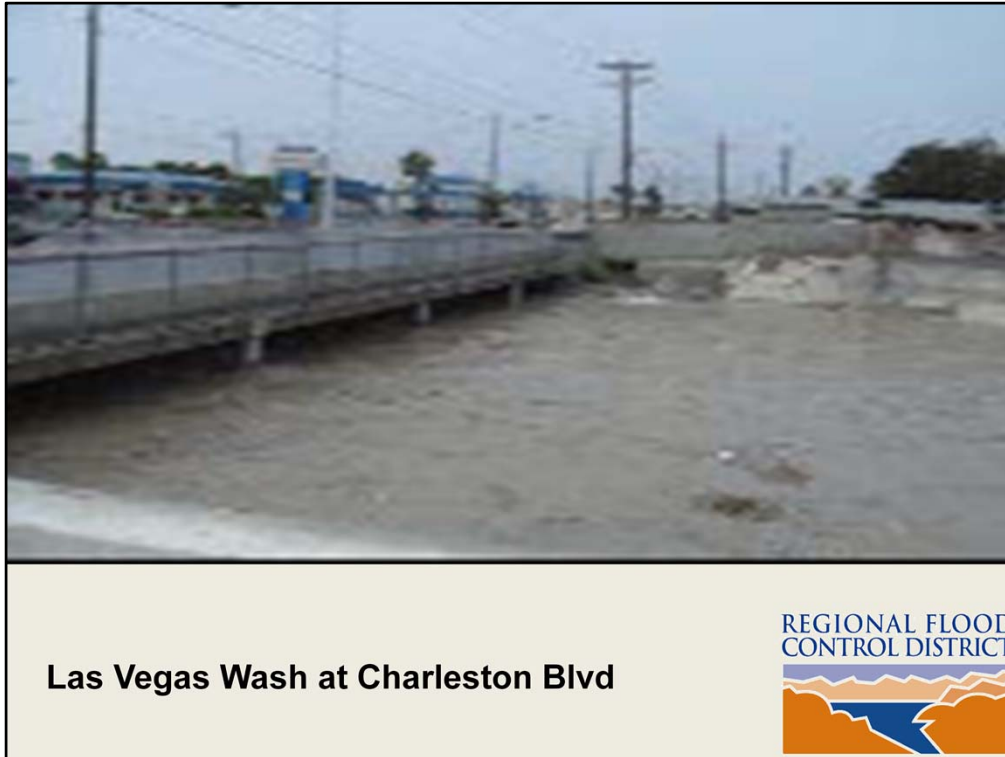
Las Vegas Wash at Charleston Blvd.

This is part of the project area that is being addressed in the Las Vegas Wash Sloan Channel to Cedar Avenue project. In June 2012 the Board approved Resolution 12-5 which set aside \$35M for the design and construction of this project.

Channel is 90 feet wide

Channel depth is 12 feet

Discharge estimate is 3600 cfs; MPU flow rate is 14,400 cfs.

While it appears that the channel has adequate capacity at this flow rate, there is a 51" sanitary sewer pipe hanging from the bottom of the bridge.

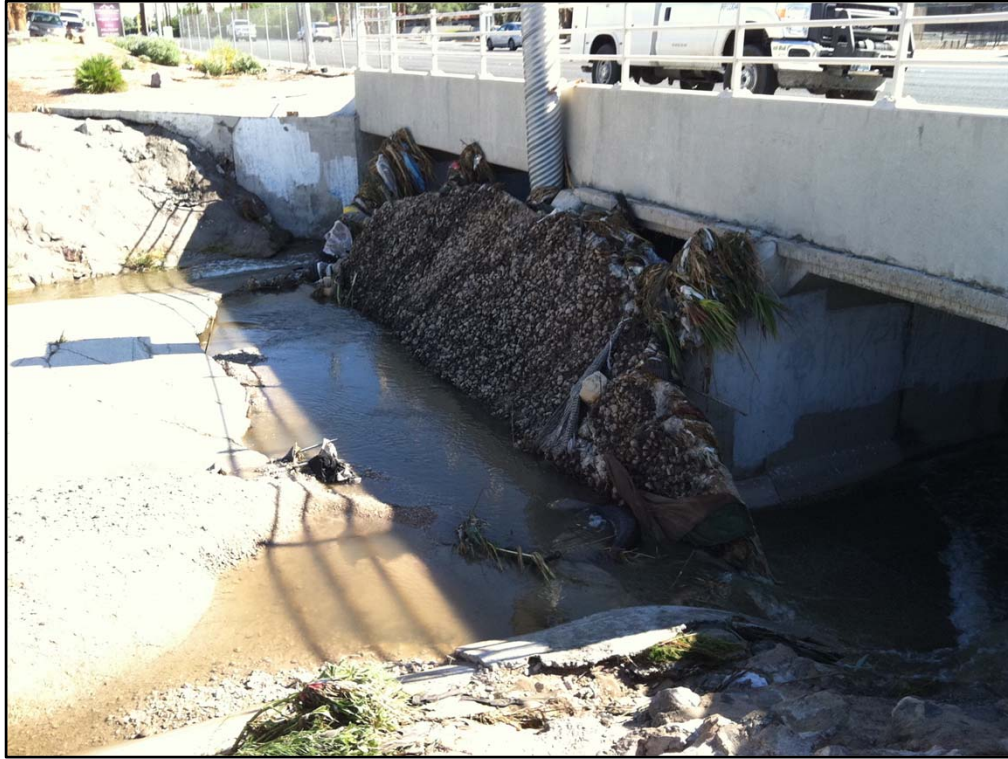
Flamingo Wash on the downstream (east) side of Eastern
Note that there is more flow in the two outside cells than there is in the middle three cells...

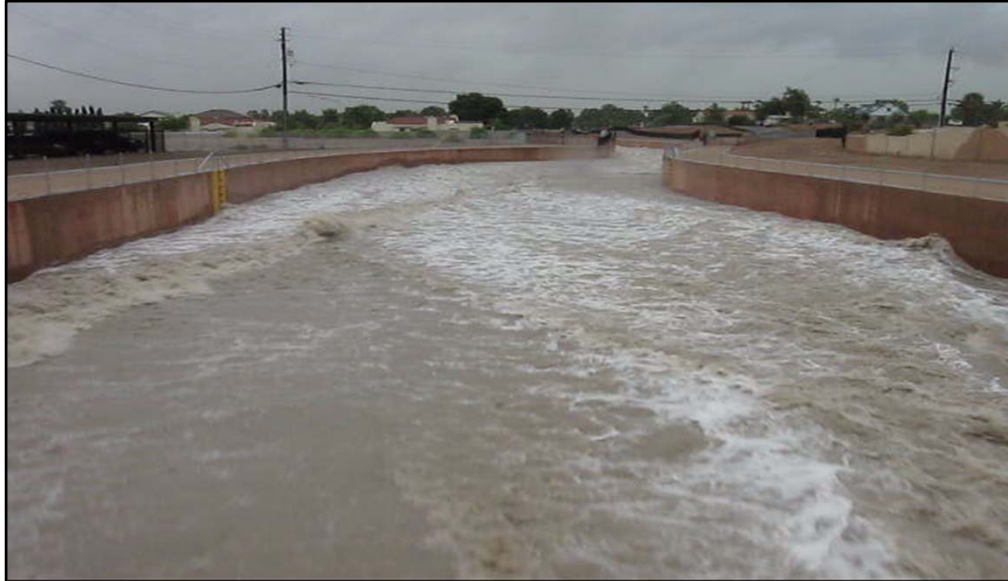
And here is the reason for that. Flow lifted a portion of the concrete approach to the Eastern Avenue culvert and partially blocked three of the cells. Fortunately there was no other damage that resulted from this blockage as the National Golf Course is on the upstream side of Eastern.

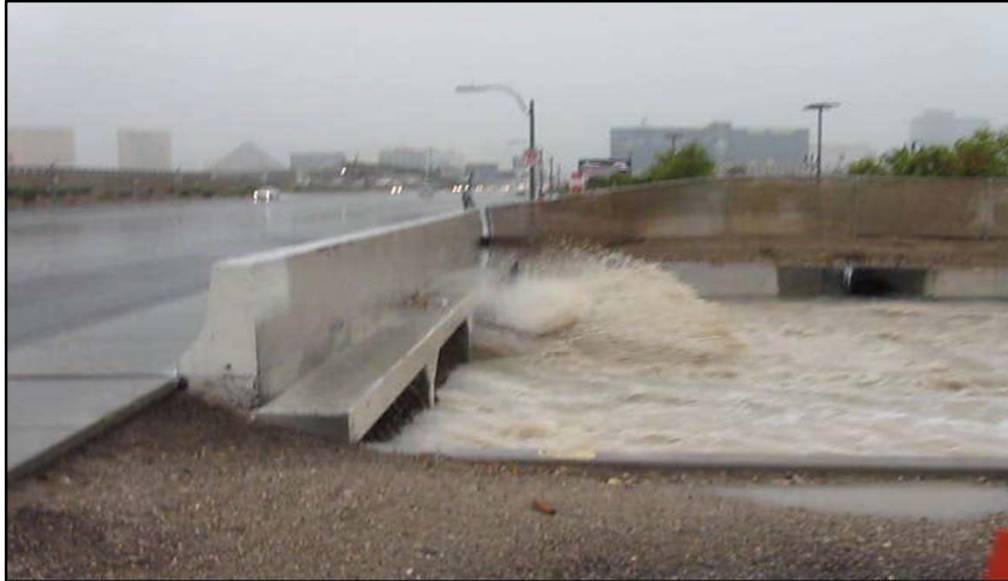
Flamingo Wash at Eastern Avenue

The recently completed Flamingo Wash project that extends from Eastern Avenue to Nellis Blvd functioned well and flows were 2 – 3 feet deep throughout this reach. Flow during this event was approximately 3400 cfs.

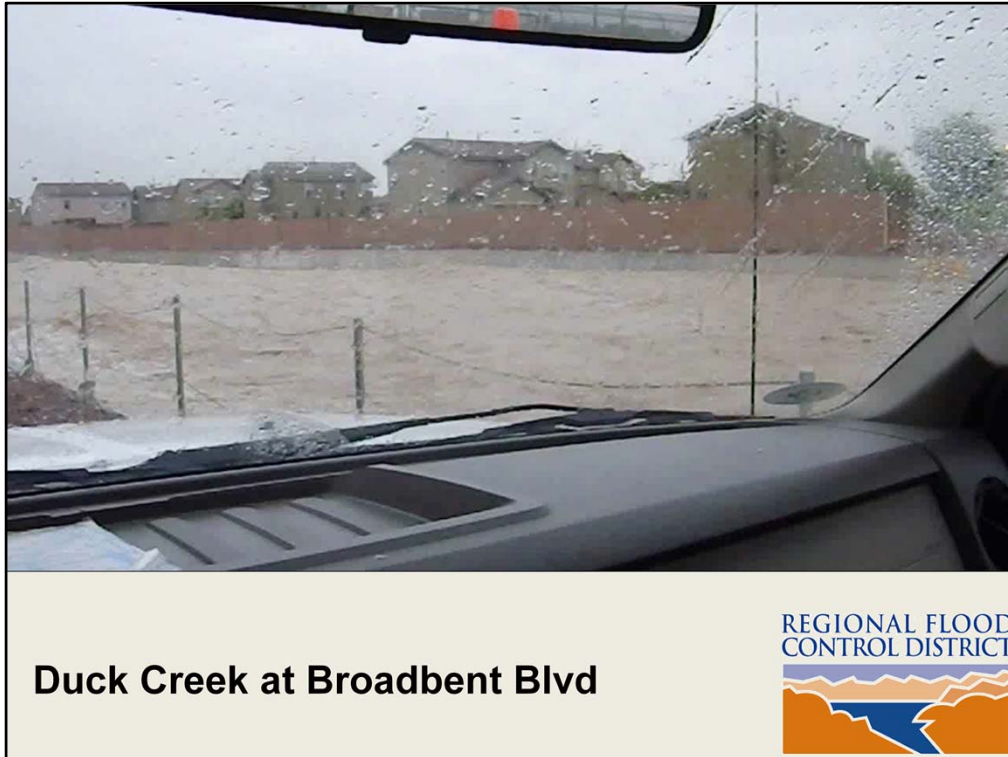
This video was shot just north of Galleria Drive. The channel is roughly 30 feet wide and 8 feet deep.

Flow is 5 1/4 feet deep

Discharge estimate is 5,500 cfs

Velocity estimate is 25+ fps (nearly 20 mph)

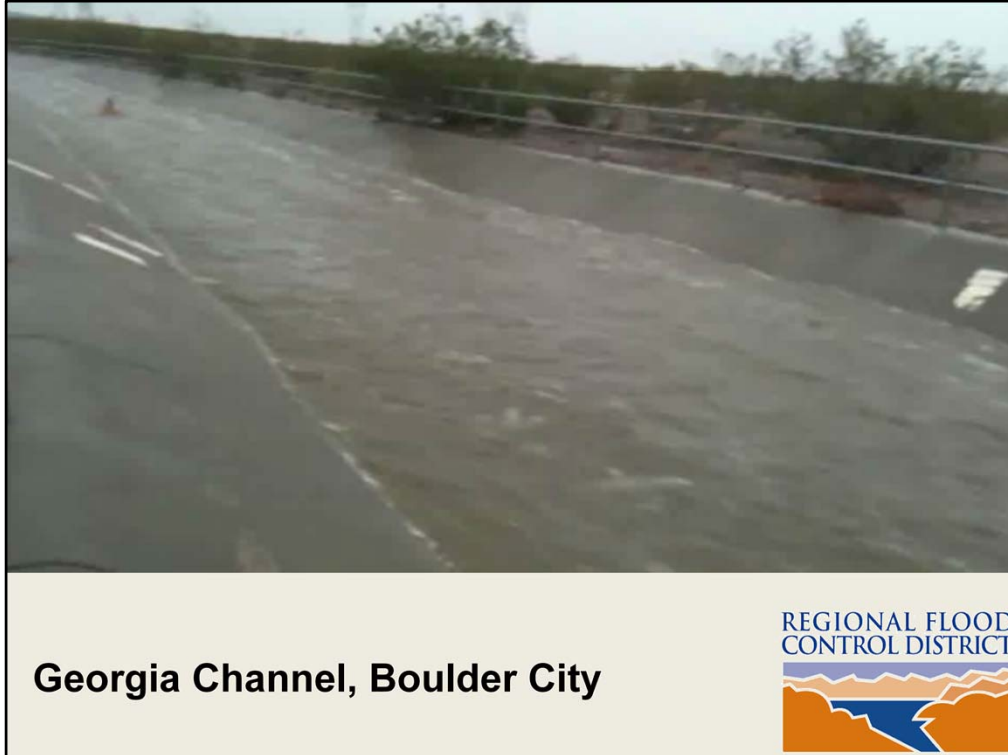
This video was shot by staff with the US Geological Survey, one of the District's partners. The channel is roughly 120 feet wide and 8 1/2 feet deep
Flow is 5 feet deep
Discharge estimate is 10,300 cfs
Velocity estimate is 20+ fps (15 mph)
Again it is clearly evident how much energy flood flows possess and how dangerous they are.
