Rainfall & Flood Event Report

August 25, 2013

prepared by
Timothy E. Sutko
Environmental Mitigation Manager
Clark County Regional Flood Control District

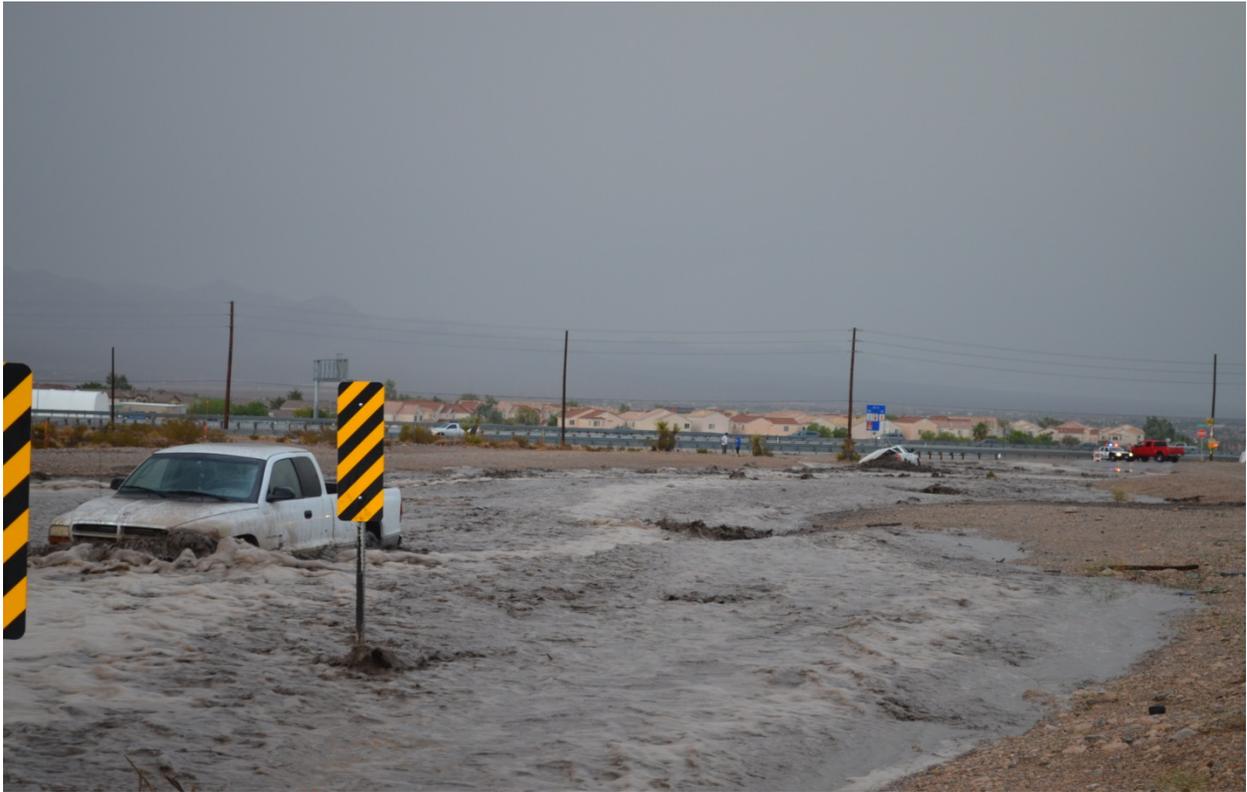
Figure 3. Grand Teton Drive west of US-95, August 25, 2013

This flood control facility did not capture all of the storm runoff. Un-attenuated debris-laden surface flow from the natural drainage areas north of the basin and south of Kyle Canyon Road caused street flooding and shoulder erosion in Grand Teton Drive east of Hualapai as well as in several other roadways. Most of the street flow in the area east of Ft. Apache Road and bounded by Racel Street and Iron Mountain Road was captured by the recently completed Floyd Lamb South EEA. The debris and extended flows (as the Kyle Canyon DB drained) created significant inconvenience and safety concerns for local residents and travelers through the area. However, aside from the roadway flooding and damages, there have been no reports of structural damages to residences, businesses, or public infrastructure.

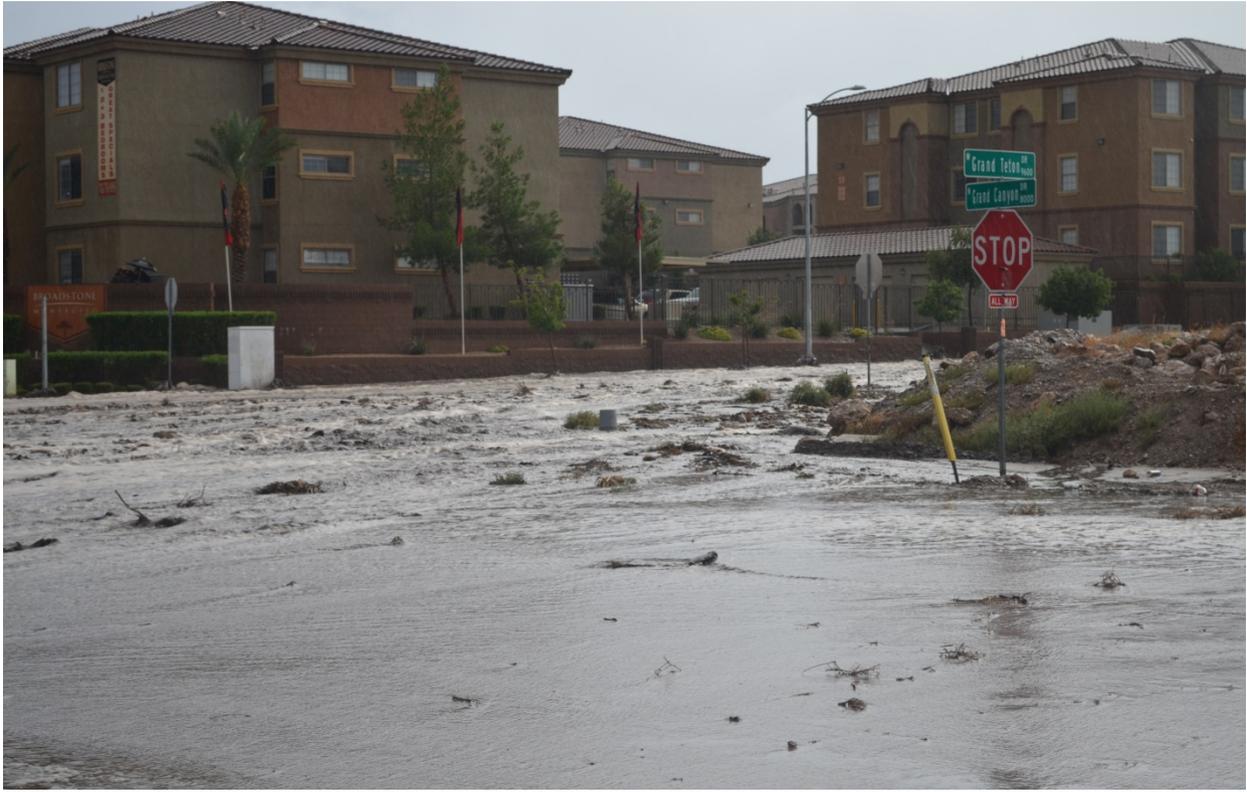
Figure 4. Grand Teton Drive at Grand Canyon Drive, August 25, 2013

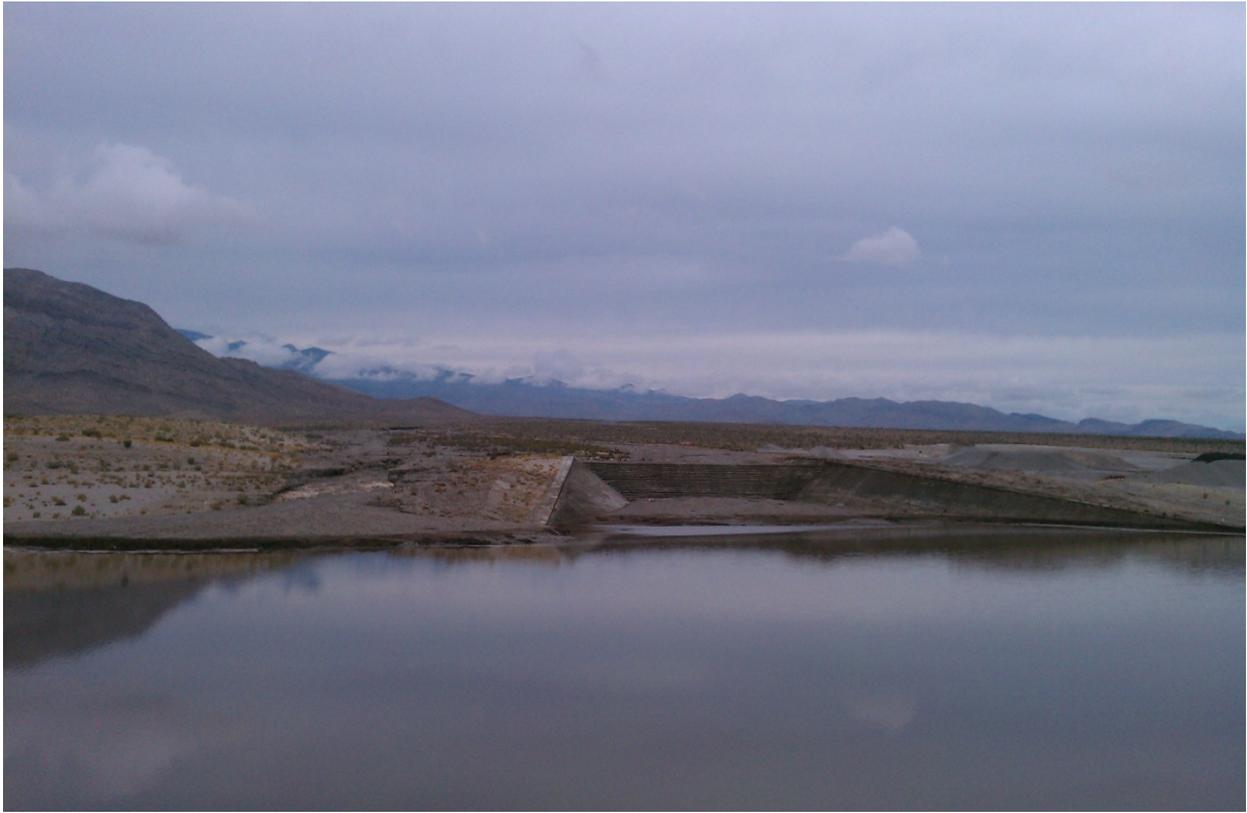
Figure 5. Kyle Canyon Detention Basin (August 26, 2013)

The Kyle Canyon DB and other flood control facilities in the northwest functioned as designed and significantly reduced downstream flooding in the impacted area. Prior to the onset of the August 25th rainfall, it is estimated that the basin was holding less than 50 acre-feet of runoff from the August 18th event; the depth of the impounded water at the plugged 7 foot wall in the outlet works was approximately 5 feet. On August 25, the water level increased to approximately 30 feet over a 4 hour period, based on reports from on-site observers. The basin captured approximately 1300 acre-feet of runoff during this event; this is roughly 40% of the basin's design storage capacity. District staff has estimated that the peak inflow to the basin was between 8000-9000 cfs; the peak outflow was roughly 300 cfs, but persisted over a 2 ½ day period as the basin slowly drained. As the water level in the basin dropped below the 7 foot level, outflow from the basin reduced to insignificant levels.

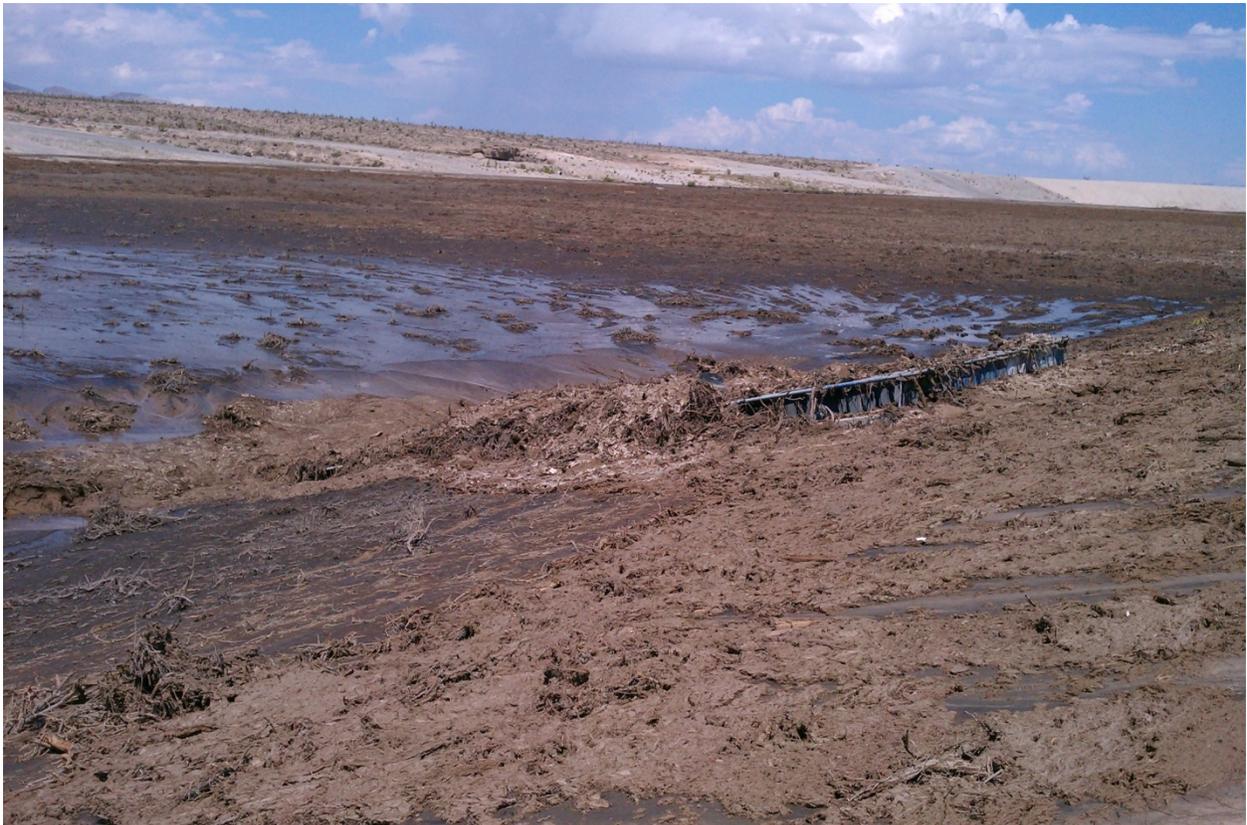
Figure 6. Debris washed into Kyle Canyon Detention Basin (August 28, 2013)

inlet and flow at that location was several feet deep and at least 550 feet wide. While there was significant erosion near this inlet, the functional integrity of the basin has not been compromised. It is estimated that this facility captured at least 70 acre feet of sediment and debris that were entrained in the flood flows.

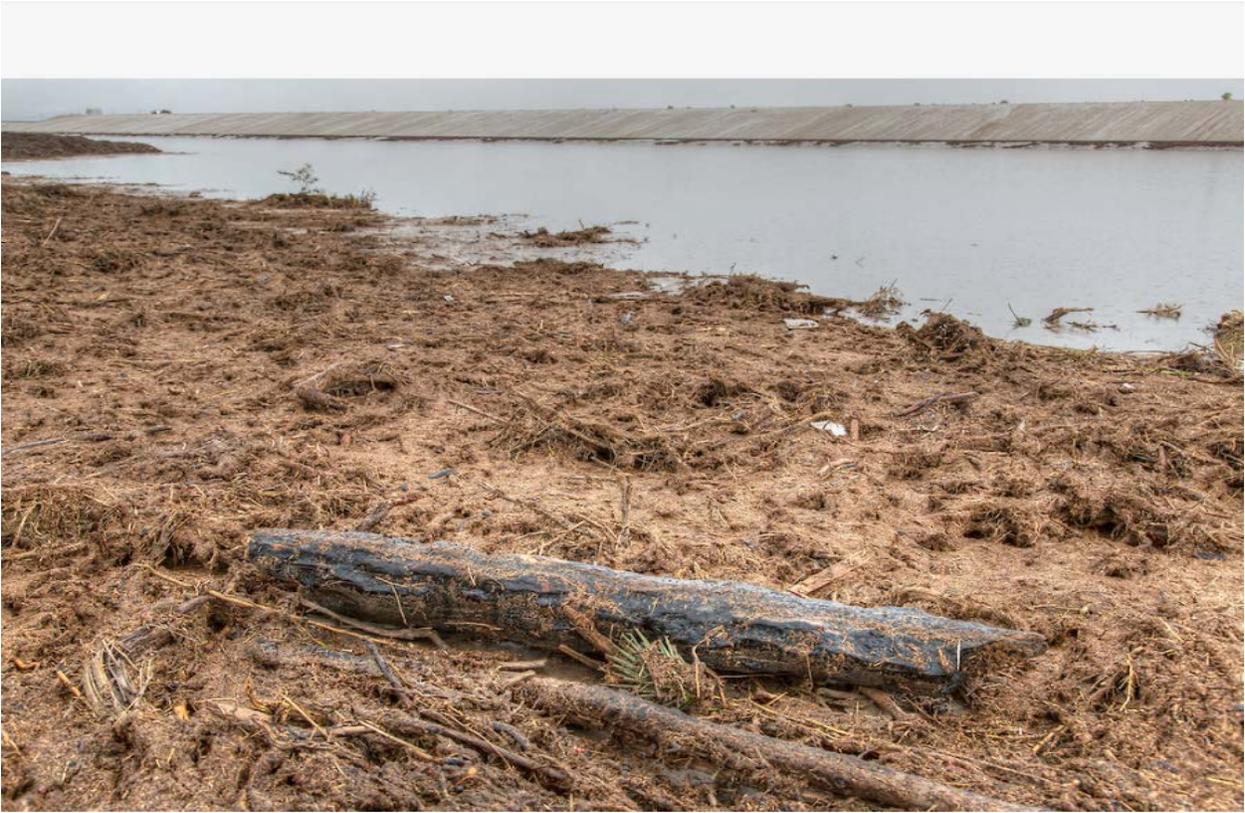
Figure 7. Debris washed into Kyle Canyon Detention Basin (August 27, 2013)

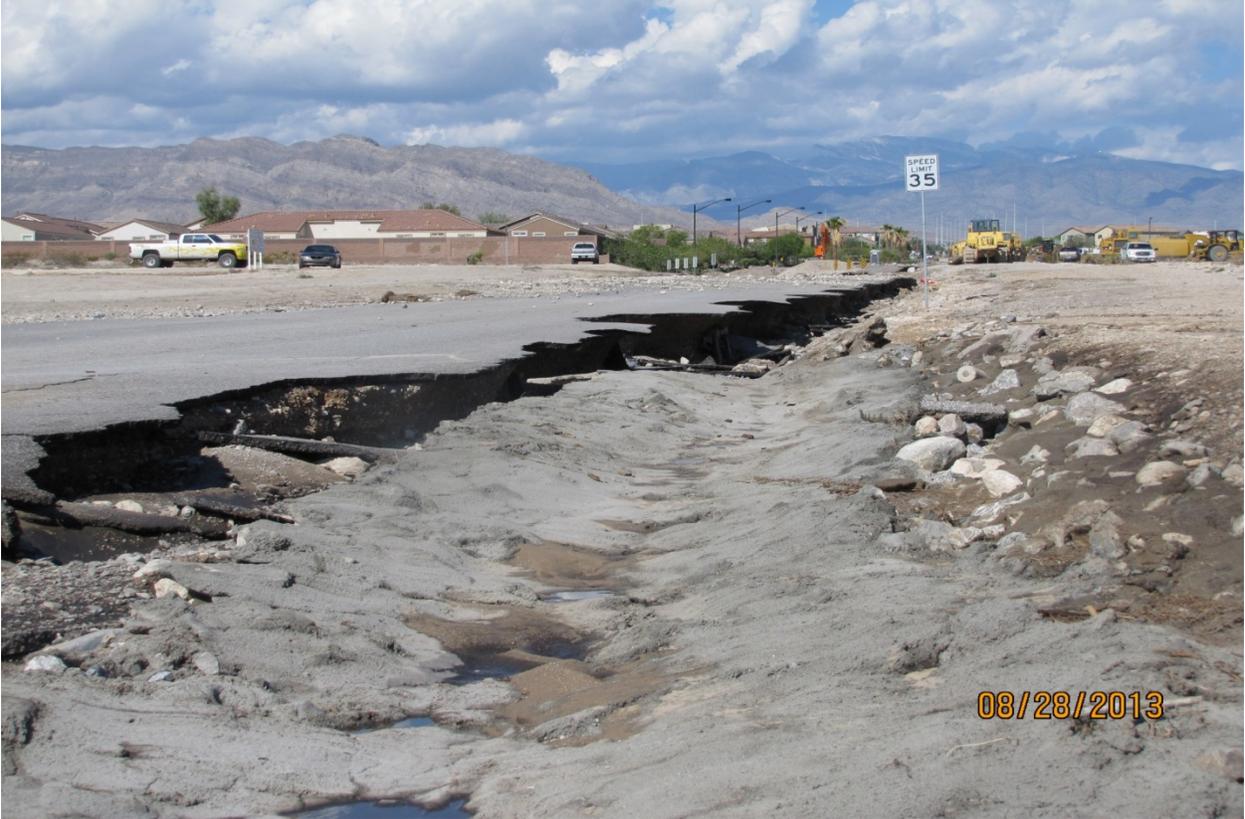
Figure 8. Damage to Grand Teton Drive resulting from August 25, 2013 flooding

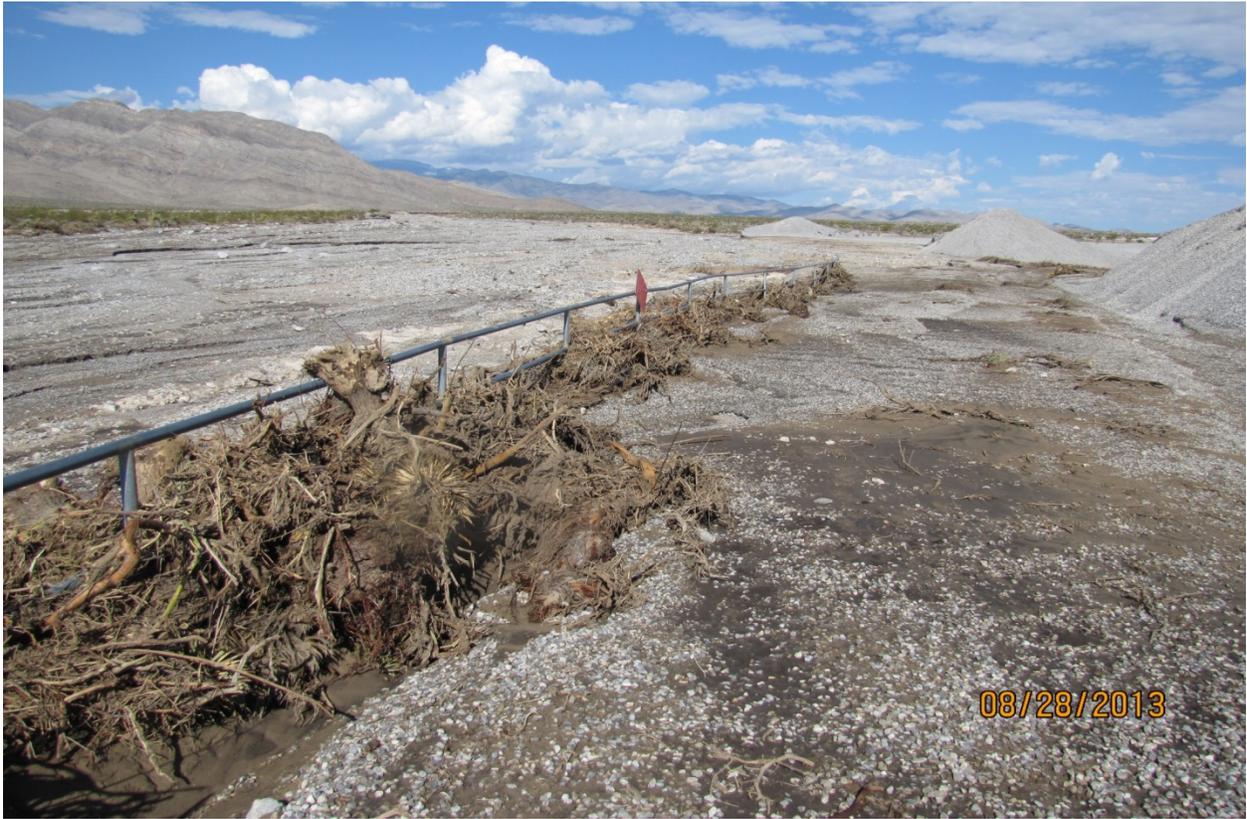
The Kyle Canyon DB has three designed inflow locations along the west side of the basin. Post-event inspections of the facility determined that runoff entered the basin only at the northernmost

Figure 9. Northernmost inlet structure at Kyle Canyon DB, resulting from August 25, 2013 flooding

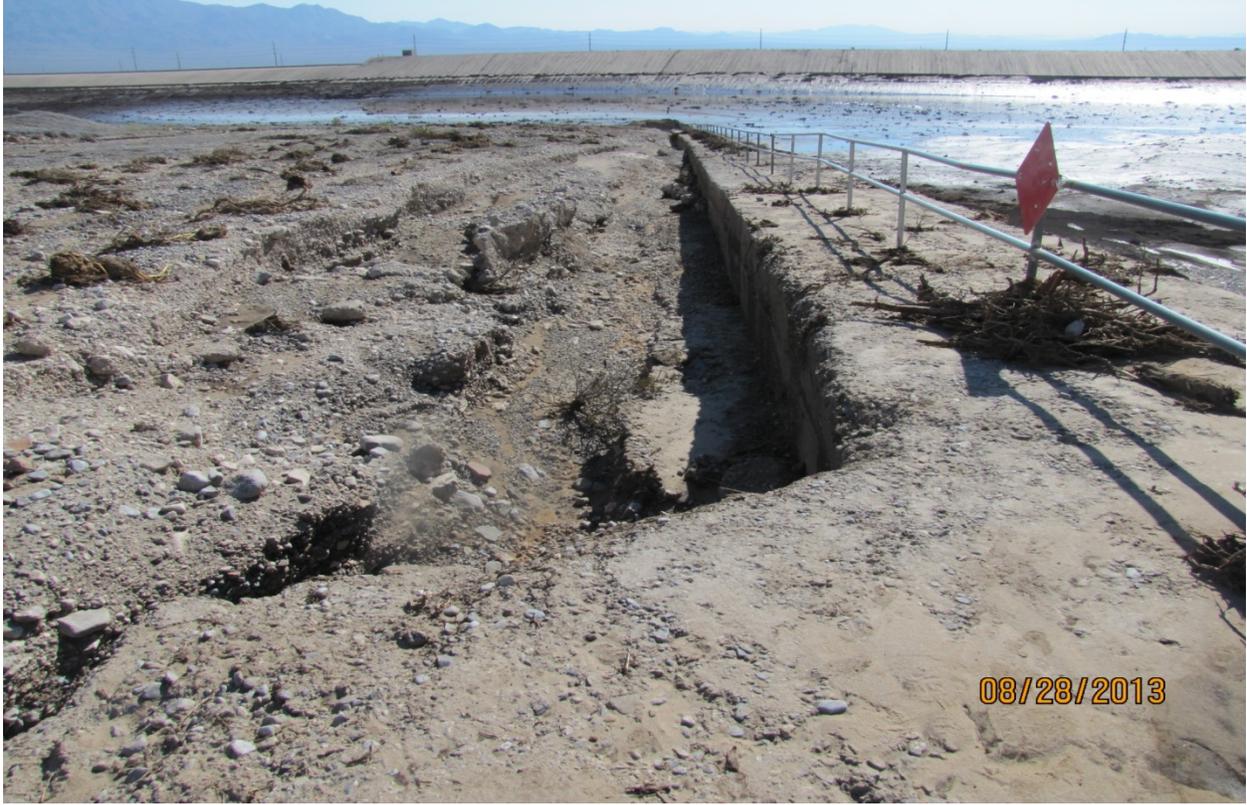
Figure 10. Erosion along inlet structure at Kyle Canyon DB, resulting from August 25, 2013 flooding
