FLOOD PLAIN INFORMATION

MUDDY RIVER

VICINITY OF OVERTON

CORPS OF ENGINEERS, U S ARMY
LOS ANGELES DISTRICT, CALIFORNIA
JUNE 1974

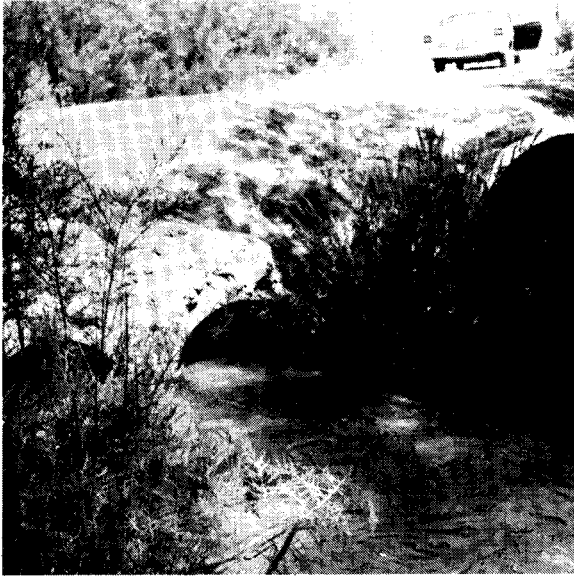
Figure 1 – Downstream side of Cooper Avenue culvert at river mile 9.16.

Obstructions – During floods, debris collection or deposition at bridges and culverts could decrease their carrying capacity and cause greater water depths (backwater effect) upstream from these structures, as well as overflow of adjacent areas. The great amount of debris deposited is, in itself, an obstruction; and the depth of flow will increase as deposition increases until the water either begins eroding the deposited material or finds a new path around the area. Data on known bridge obstructions are shown in table 5. The location of some debris collecting points can be readily predicted, for example, at bridges or embankments. The majority of the debris collection points will vary from flood to flood and could act either as debris collectors or as debris contributors (erosive area) during the same flood. Prediction of the exact locations of erosion or deposition for any one flood is not always possible. However, all sites shown as flooded will experience both erosion and deposition in the future, as they have in the past. The flood depths shown in this report reflect these obstructions at all points that have a probability of debris accumulation.

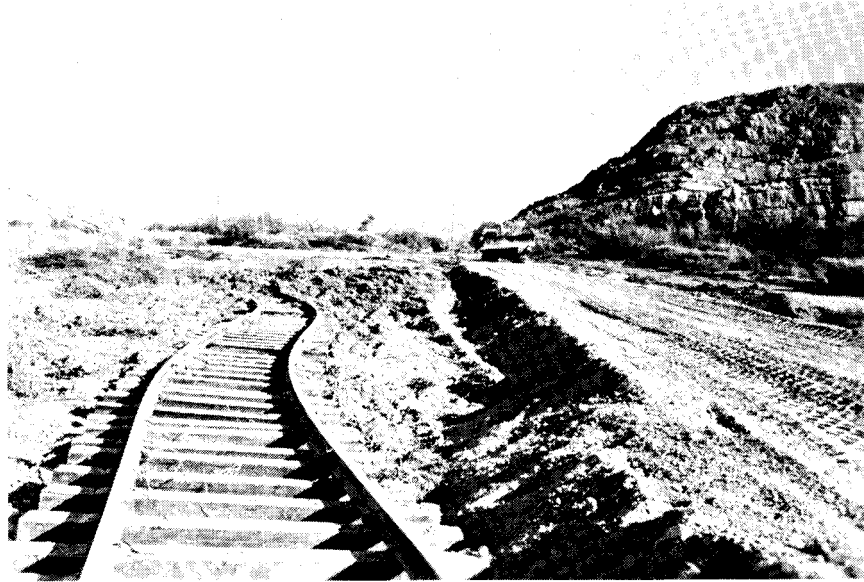
Figure 6 — Railroad damage due to flooding in the Narrows between upstream limit of study and Glendale during the flood of 1960.

Figures 5 through 15 indicate the damage resulting from the 1960 flood.

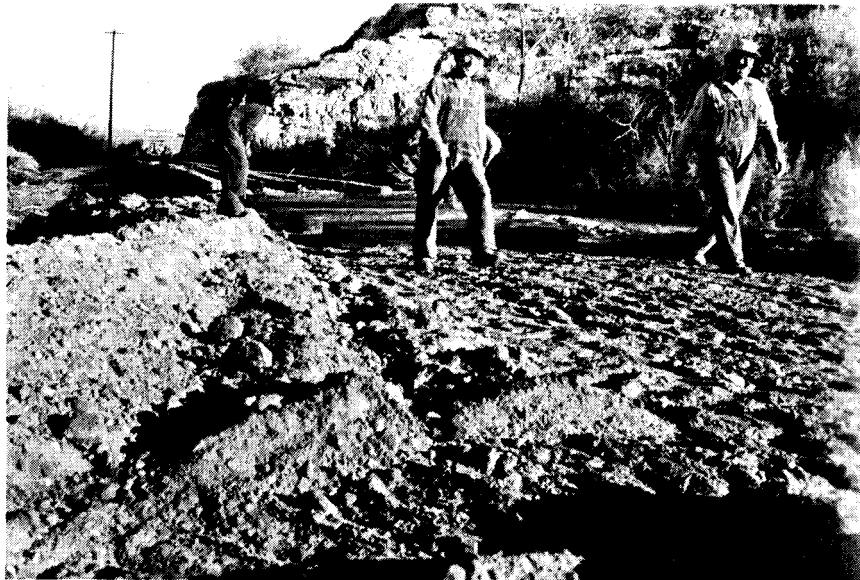
Figure 7 – Repair of railroad damage due to flooding in the Narrows between upstream limit of study and Glendale during the flood of 1960.

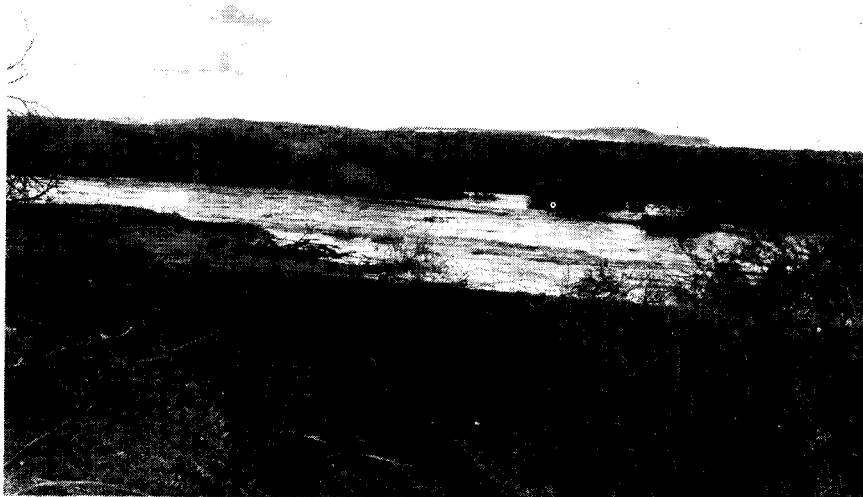
Figure 8 – Flooding on the Muddy River between Overton and Logandale during 1960 flood.

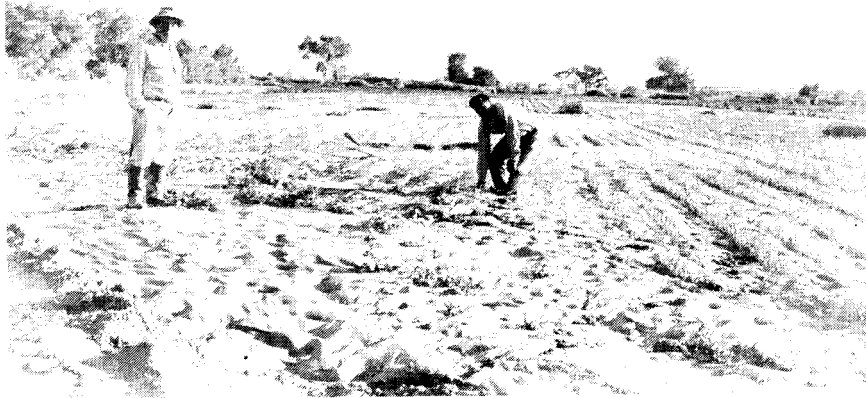
Figure 9 – The 1960 flood laid to waste the Yamashita onion field located at about river mile 10.2.

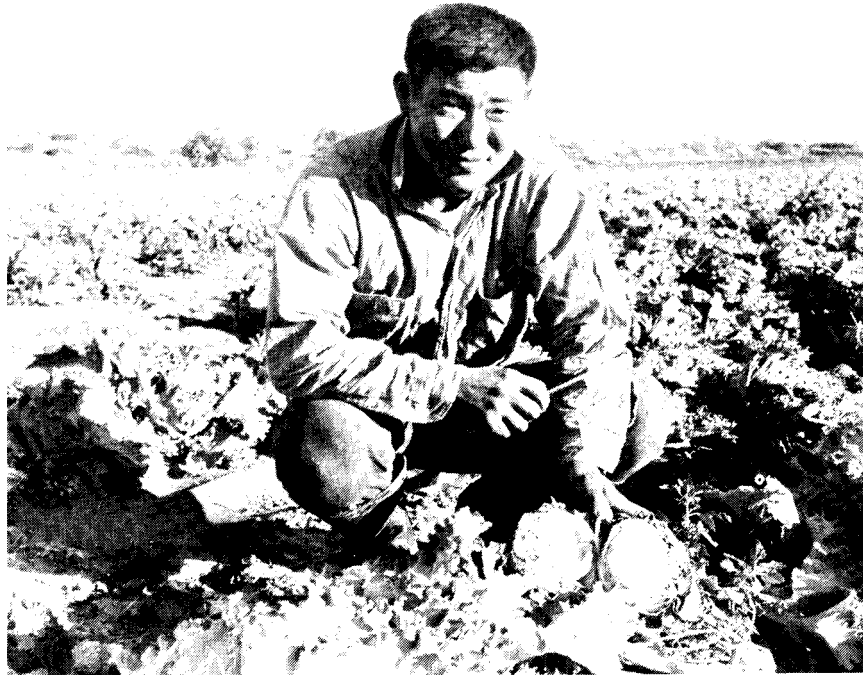
Figure 10 – Roy Yamashita inspects sediment damage to head lettuce after 1960 flood. Location is at river mile 10.2

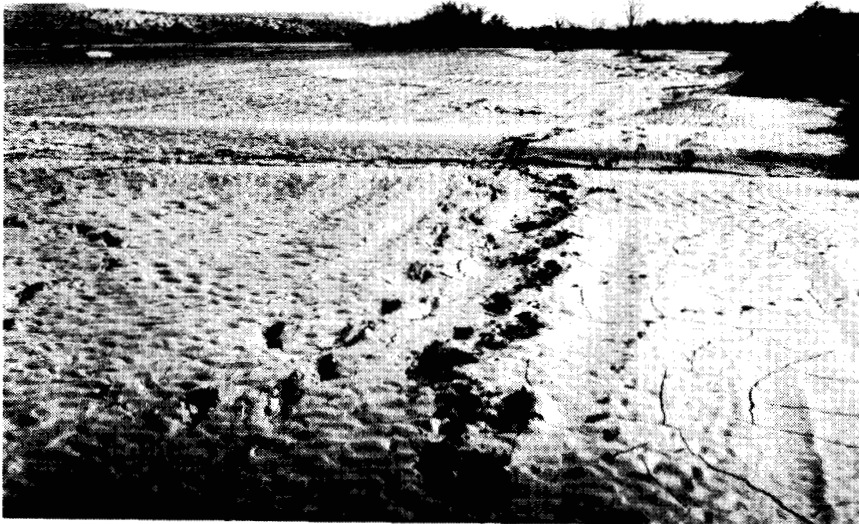
Figure 12 – A field of radishes covered by silt deposited during the 1960 flood. The location is about 3 miles north of Overton.

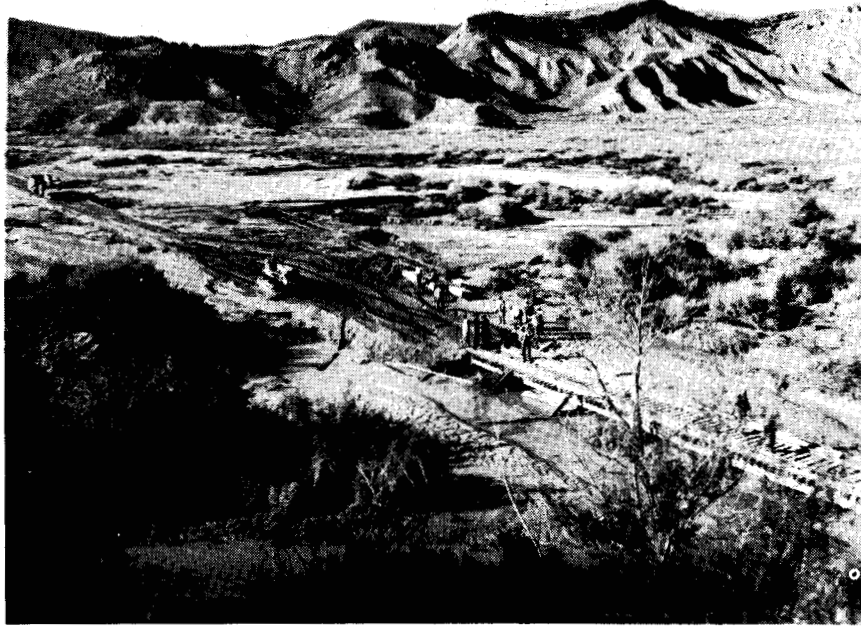
Figure 13 — Railroad embankment washout being repaired after the 1960 flood. The site is north of the study area and about 10 miles north of Overton.

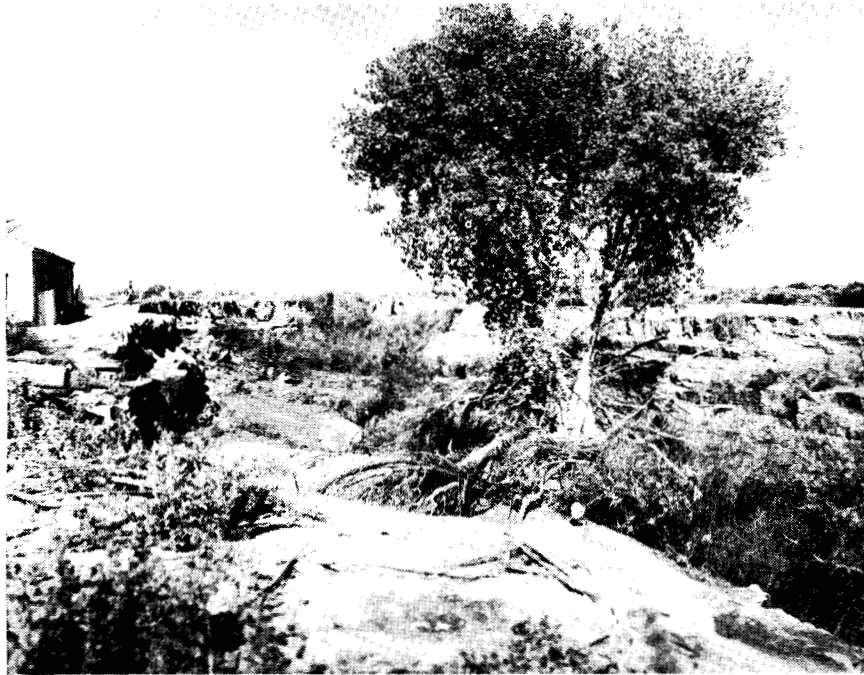
Figure 14 — Flood of 1960 along the Muddy River resulted in eroded banks and a large amount of debris piled against a tree. The debris reflects the depth of water during the flood. The site is about 3 miles north of Overton.

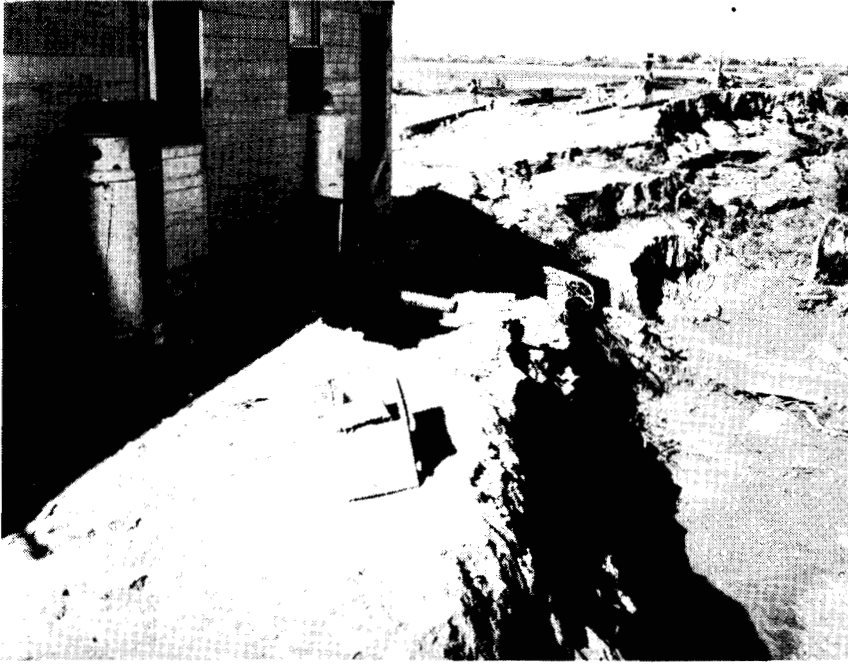
Figure 15 — A closeup view of bank erosion damage shown in Fig. 14.

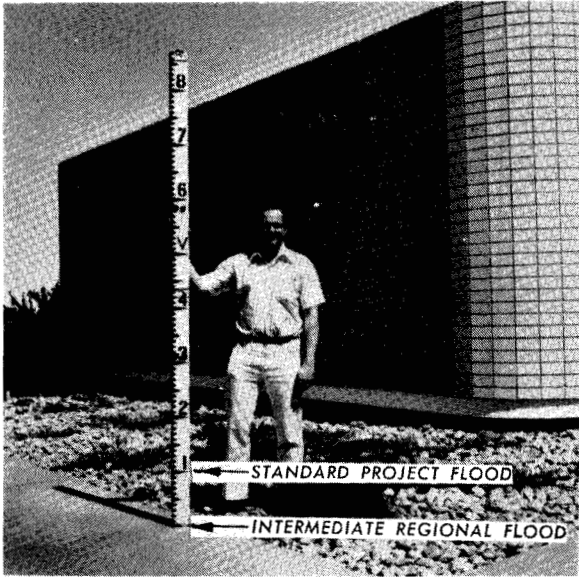
Figure 17 — Future flood heights at Moapa Valley Community Center.

Photographs, future flood heights – The levels that the intermediate regional and standard project floods are expected to reach at various locations in the study area are indicated in figures 17 through 20.

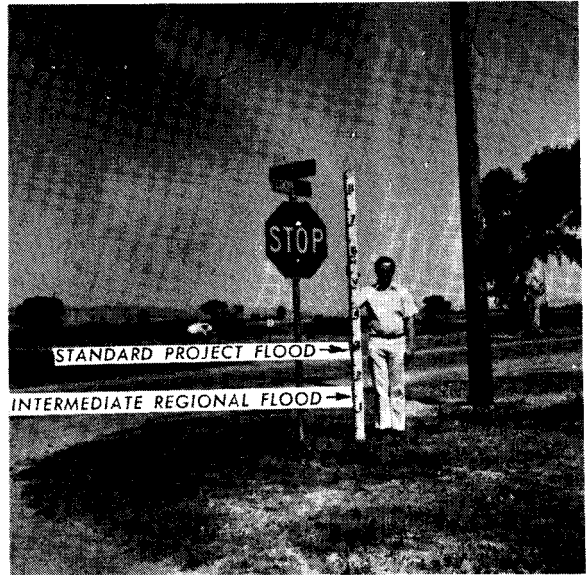
Figure 18 — Future flood heights at Cooper Avenue and Shurtliff Street.

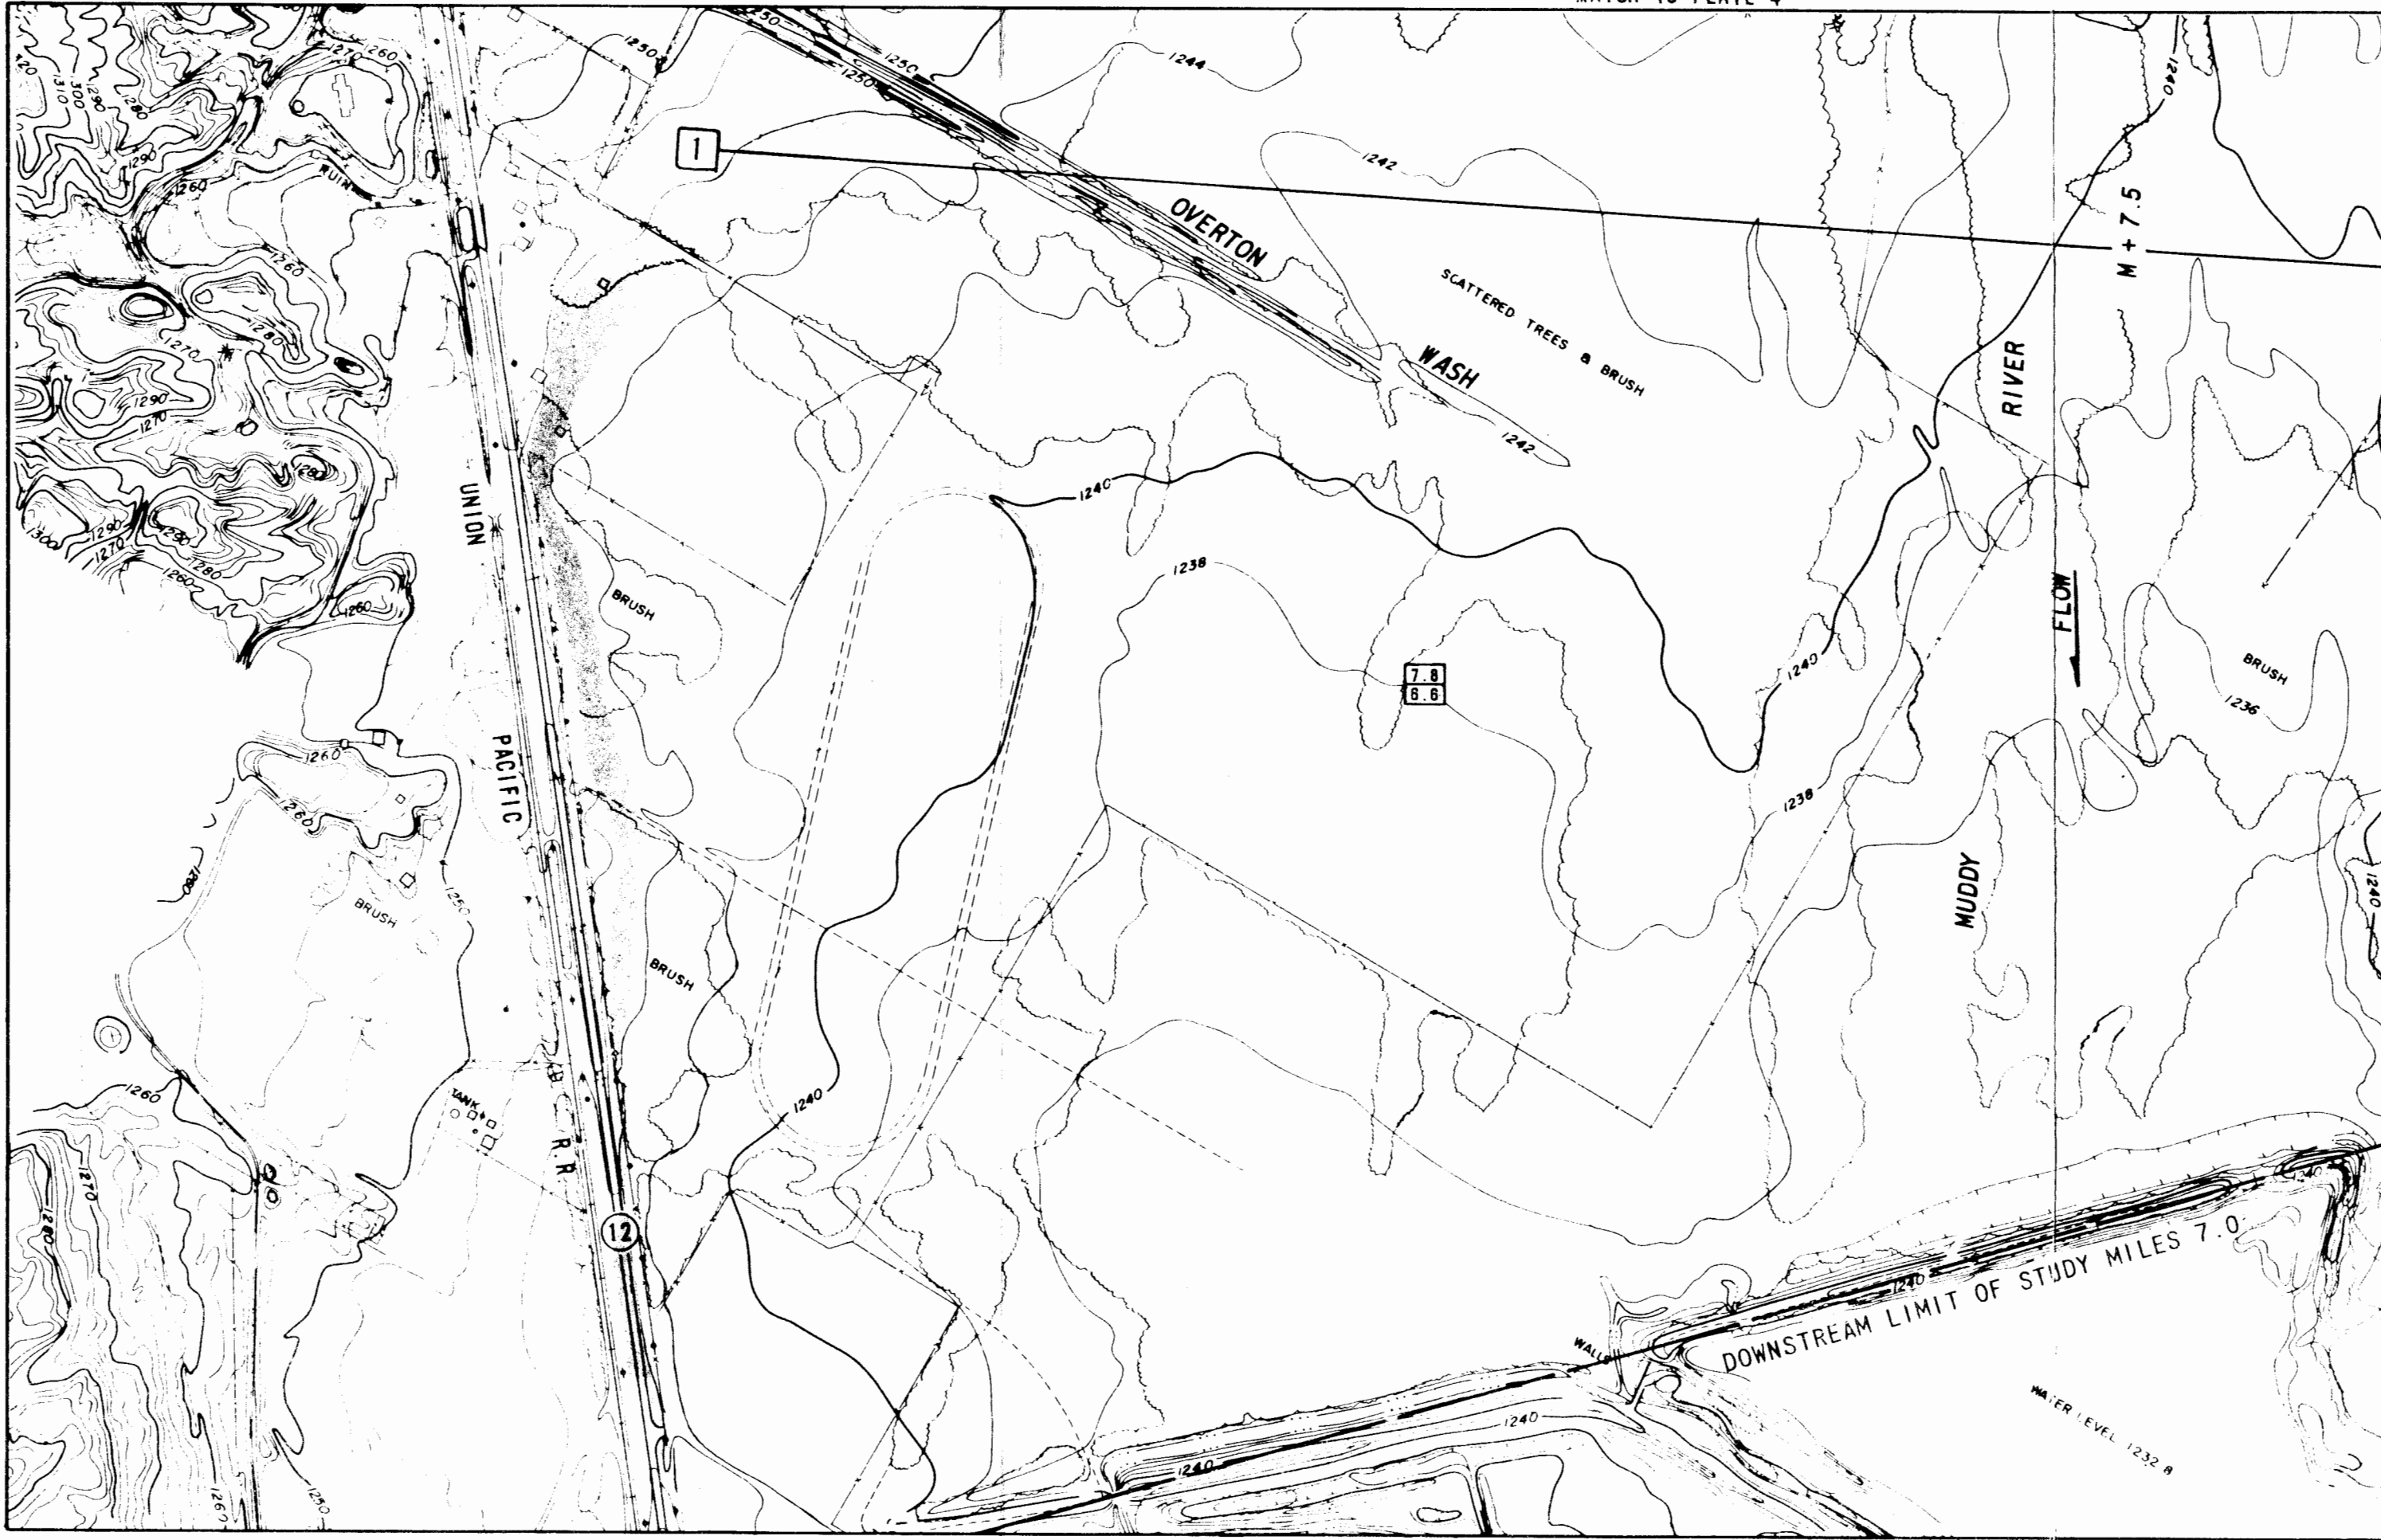
FLOODED AREAS

Flooded areas and flood damages – The areas along the Muddy River that would be flooded by a standard project flood are shown on plate 2, which is an index map to plates 3 through 13. Areas that would be flooded by the intermediate regional and standard project floods are shown in detail on plates 3 through 13. These areas include agricultural and residential sections and the associated streets, roads and public utilities in the study reach.

Limits of overflow indicated on plates 3 through 13 may vary from actual locations on the ground because of map scale limitations, deposition, erosion, inaccuracy of original topographic maps, and recent development.

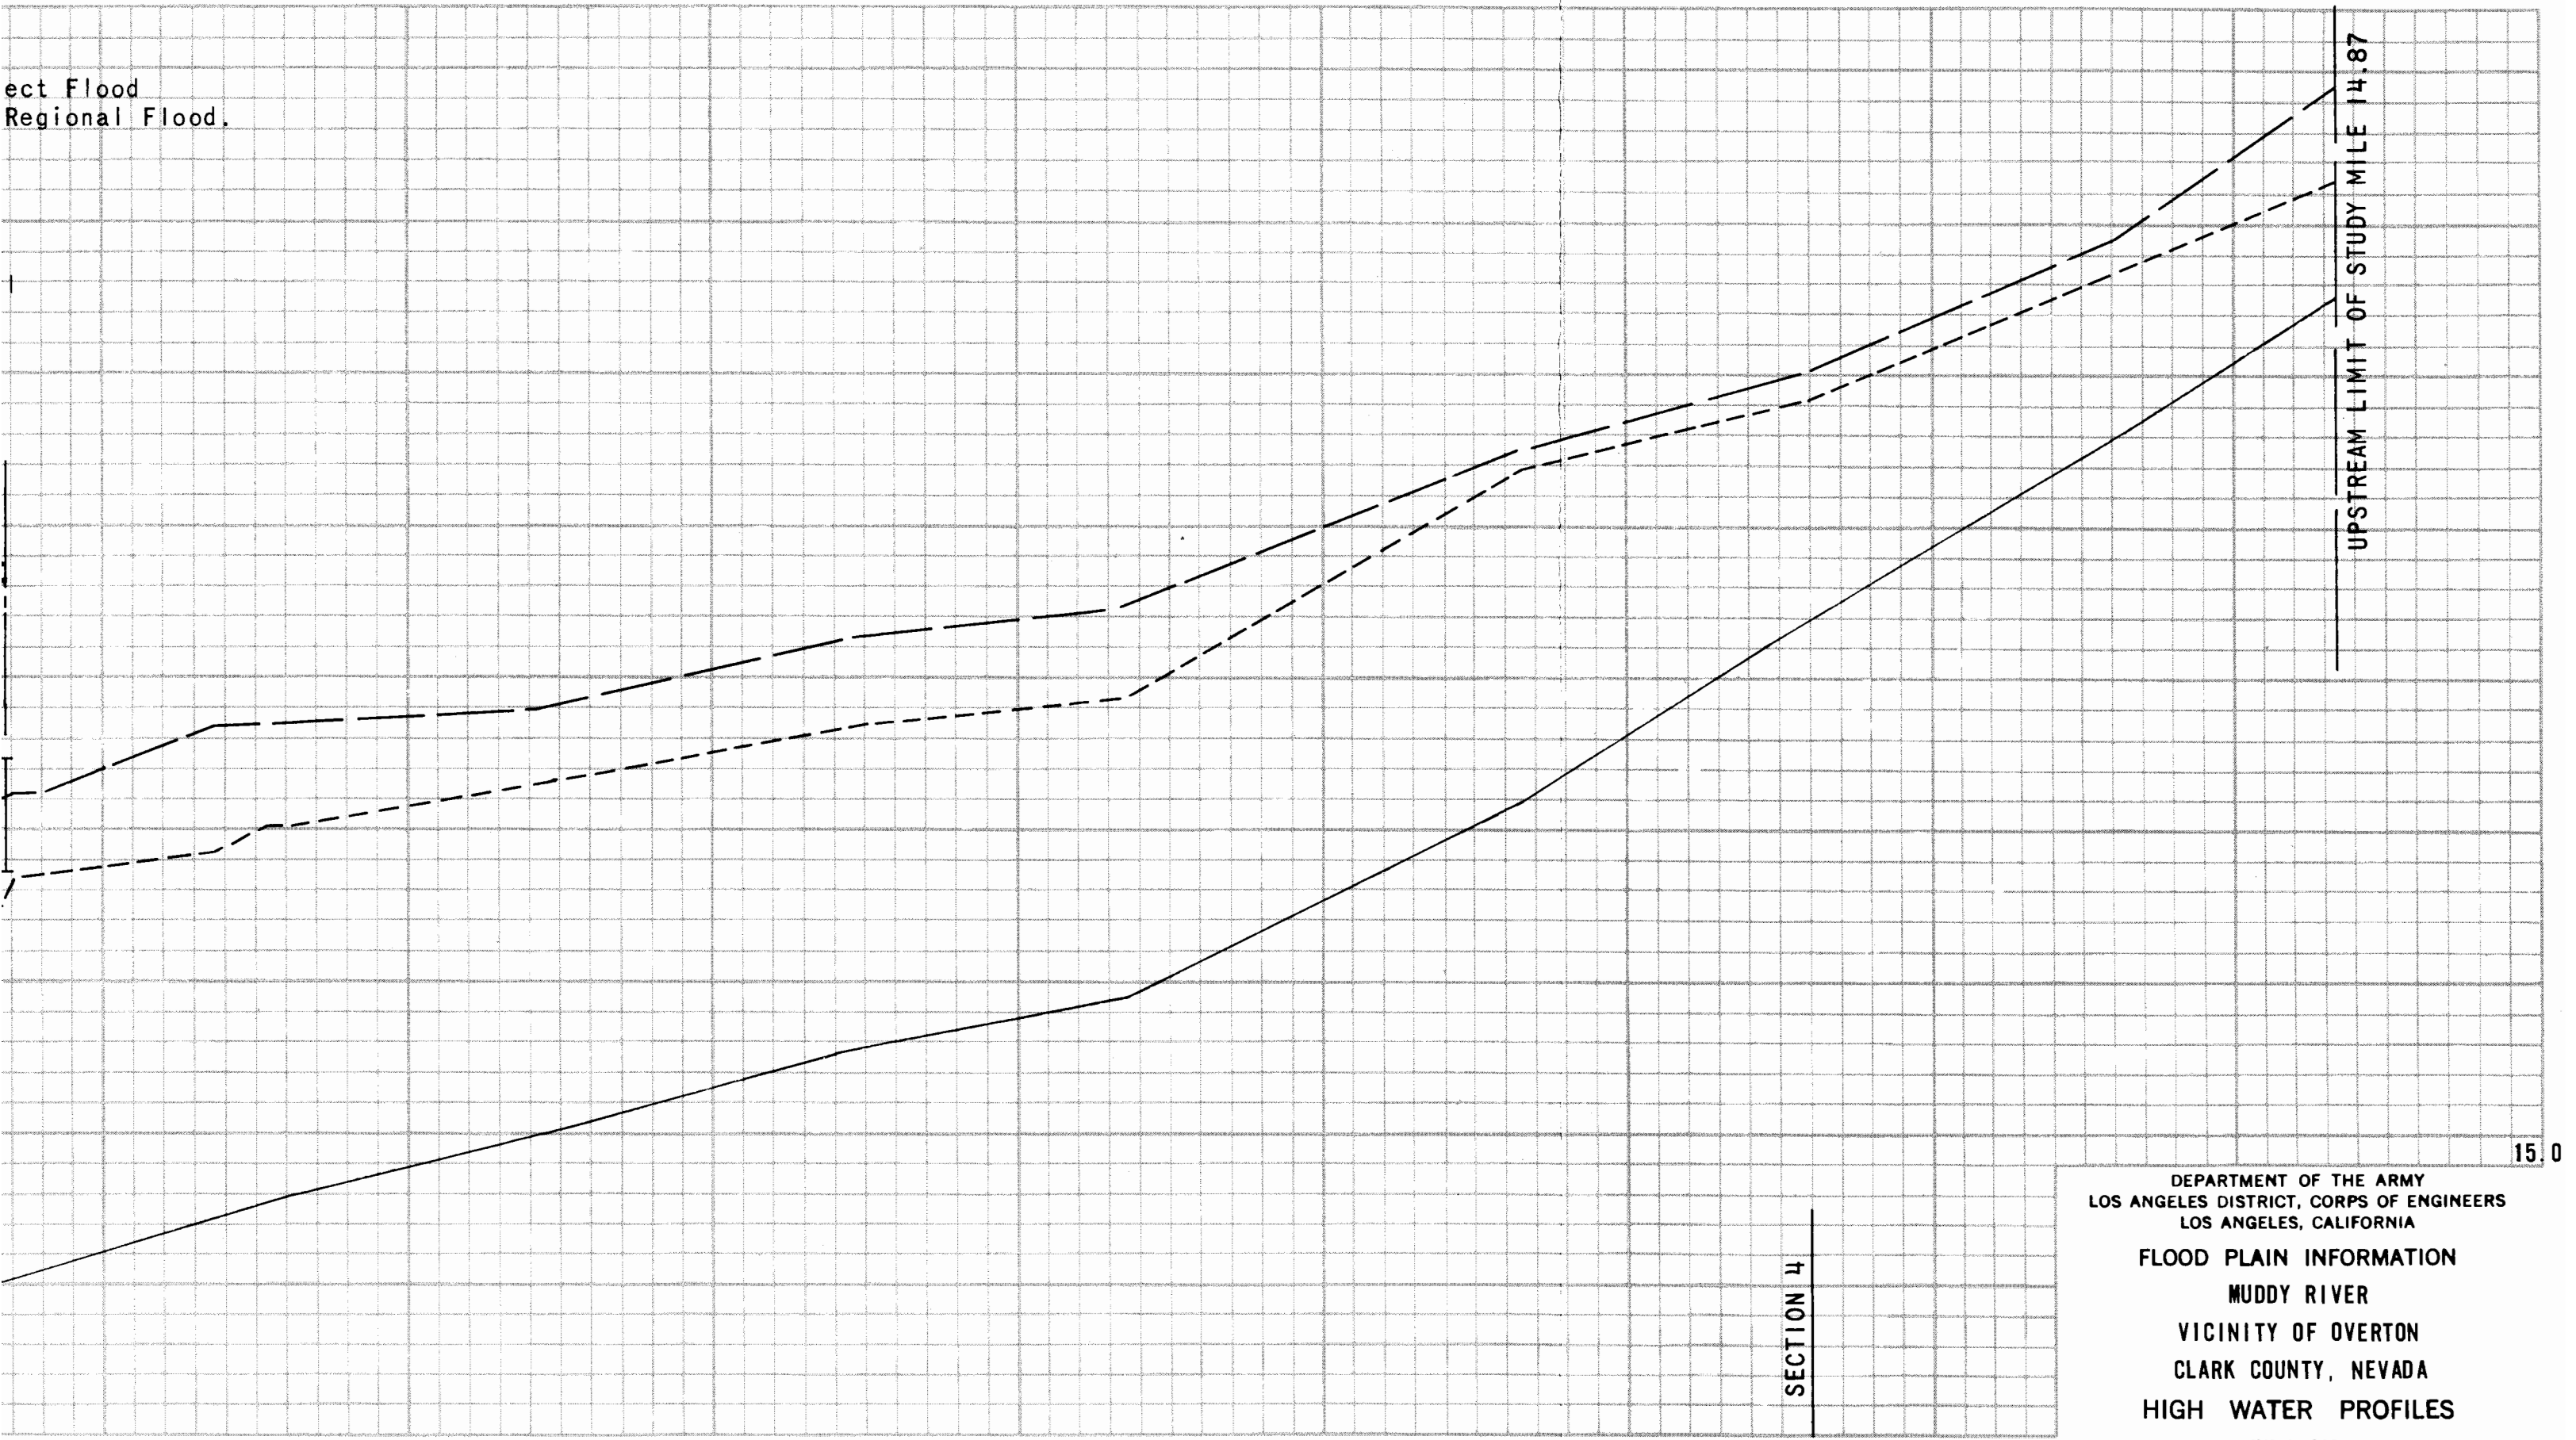
DEPARTMENT OF THE ARMY
LOS ANGELES DISTRICT, CORPS OF ENGINEERS
LOS ANGELES, CALIFORNIA
FLOOD PLAIN INFORMATION
MUDDY RIVER
VICINITY OF OVERTON
CLARK COUNTY, NEVADA
HIGH WATER PROFILES
JUNE 1974

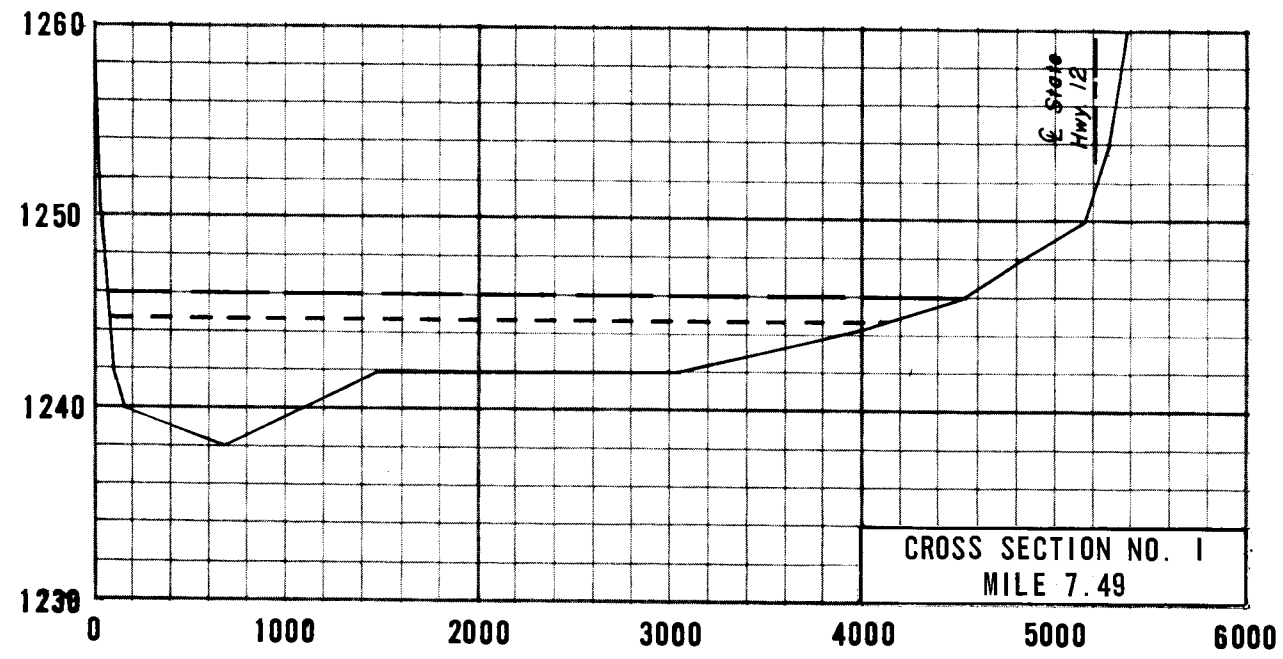
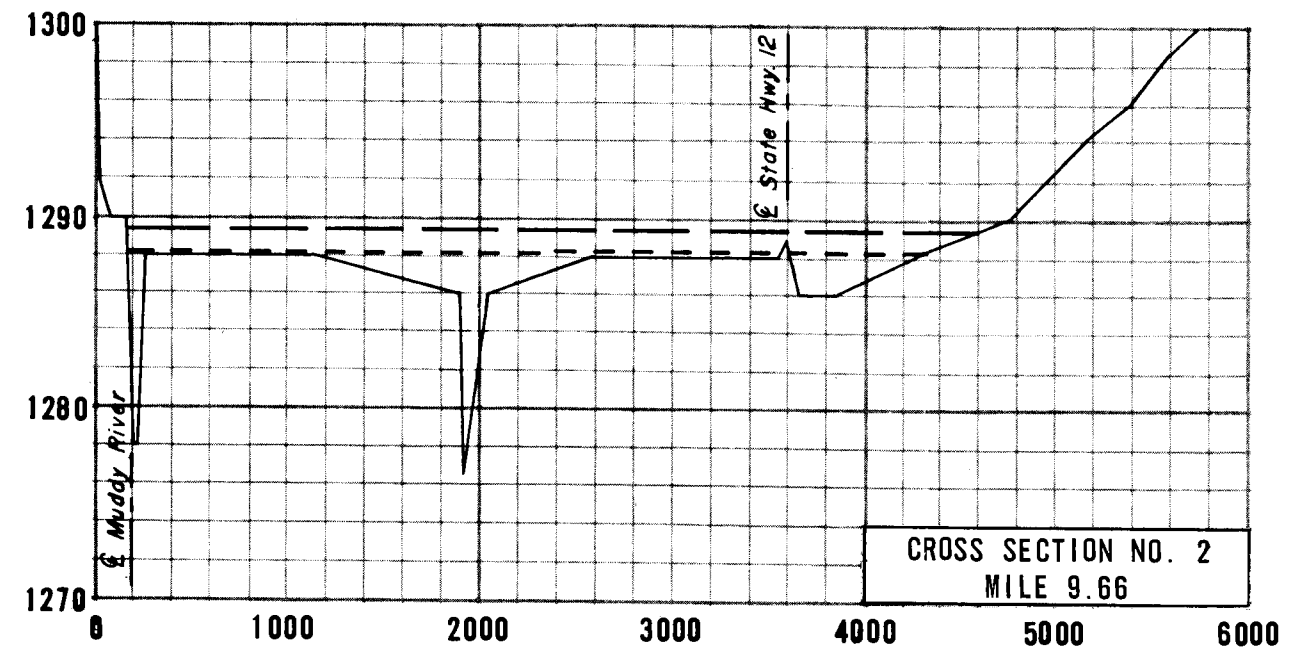
FLOOD PLAIN INFORMATION
 MUDDY RIVER
 VICINITY OF OVERTON
 CLARK COUNTY, NEVADA
 SELECTED CROSS SECTIONS
 JUNE 1974

1. HORIZONTAL DISTANCE IN FEET.
2. SECTIONS TAKEN LOOKING DOWNSTREAM.
3. ADDITIONAL CROSS SECTIONS WERE TAKEN BUT NOT SHOWN AND ARE AVAILABLE AT THE DISTRICT OFFICE.

Because of the greater depth of flooding, a higher velocity of flow, and a longer duration of flooding during a standard project flood, damage would be more severe than during an intermediate regional flood. Extensive deposits of silt and debris would occur in many parts of the flooded areas. Plates 14 through 17 show flood profiles of the intermediate regional and standard project floods. Depth of flow in the channel can be estimated from these illustrations. Typical cross sections of the flood plain at selected locations, together with the water surface elevation and lateral extent of the intermediate regional and standard project floods, are shown on plate 18.
